**Flood Control Project Maintenance
Levee Inspections**
LMA District Cover Sheet
Spring 2018 Levee Inspection Results

Sacramento Maintenance Yard Cache Creek

Spring 2018 Levee Inspection Results

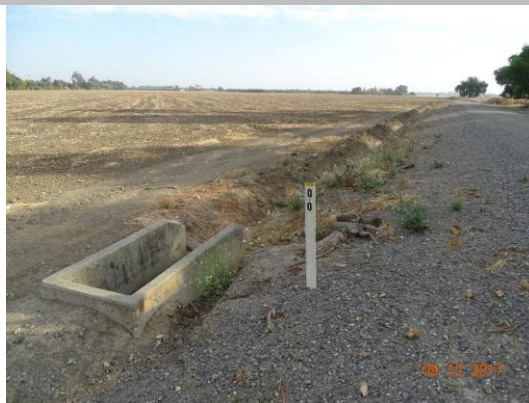
Photo 1 of 2 : SP_2018_ST0001_259_48_20180306_00036.jpg

View of the ditch at the landside levee toe. Fall 2017.

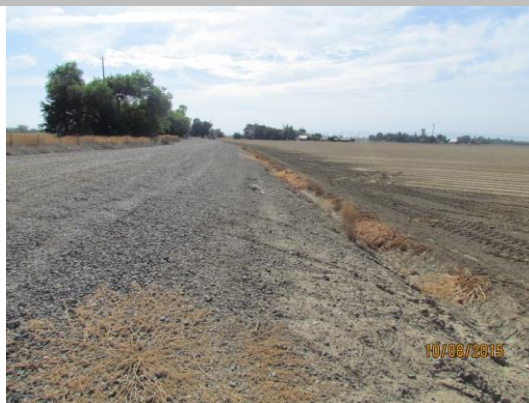
Photo 2 of 2 : SP_2018_ST0001_259_48_20180306_00037.jpg

View of the ditch on the landward side of the levee looking upstream.
Fall 2015.

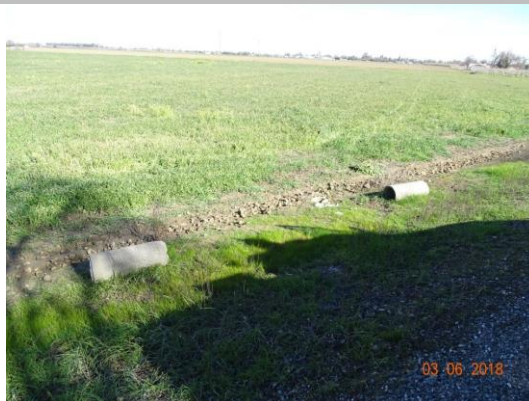
Photo 1 of 1 : SP_2018_ST0001_259_41_20180308_00070.jpg

LM Start	1.04	Rating **	M	Issue No.	41
LM End	1.04	Issue Type +	En	Location *	LS
Category	Earthen Levee			GPS Latitude/Longitude	
				Start	End
Item	Encroachments			38.720327 °	38.720327 °
				-121.813742 °	-121.813742 °
DWR ID	DWR_ST0001_01_s_2018_41				
Comment Code					
DE : Debris					
Inspector Comment					
Broken concrete standpipes on landside slope.

View of standpipes on landside slope. Spring 2018.

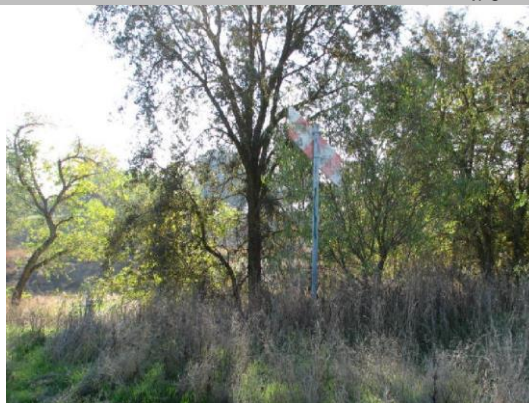
Photo 1 of 3 : UCIP_SP_2018_50432_60162.jpg

Waterside view: gasline marker

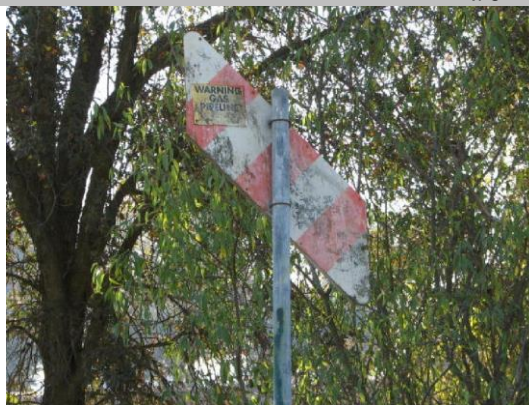
Photo 2 of 3 : UCIP_SP_2018_50432_60161.jpg

Waterside view: closer look at gasline marker

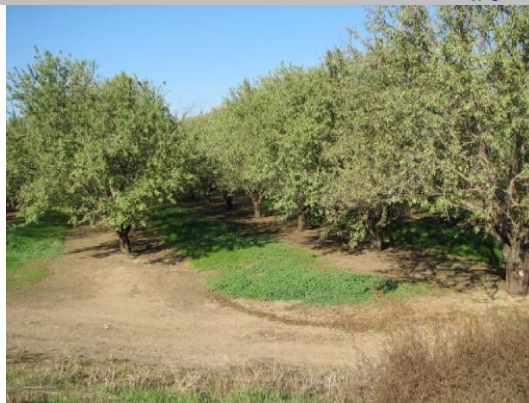
Photo 3 of 3 : UCIP_SP_2018_50432_60160.jpg

Landside view: no gasoline marker

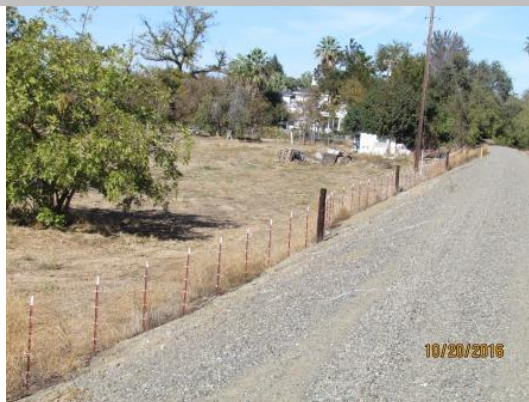
Photo 1 of 1 : SP_2018_ST0001_259_63_20180306_00044.jpg

View of fence on LS slope. Fall 2016.

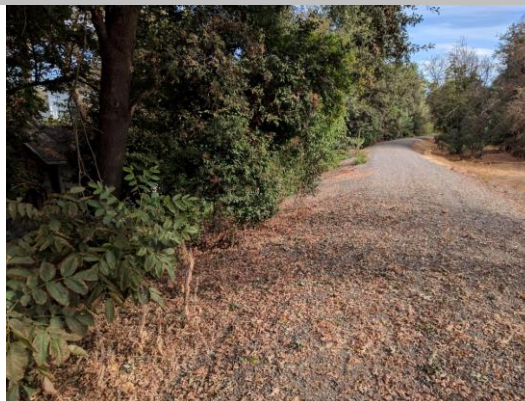
Photo 1 of 3 : SP_2018_ST0001_259_3_20180306_00002.jpg

View of thick vegetation on landside slope. Fall 2017.

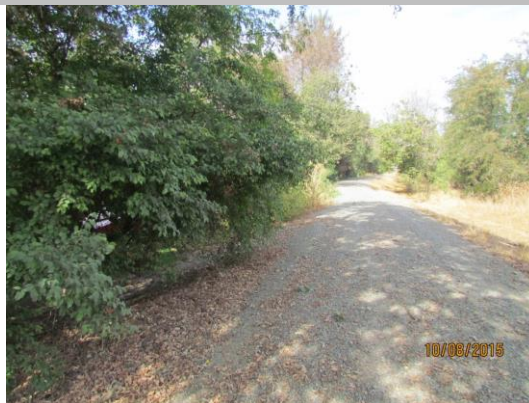
Photo 2 of 3 : SP_2018_ST0001_259_3_20180306_00003.jpg

View of the landscaping that needs to be trimmed on the landward side of the levee looking downstream. Fall 2015.

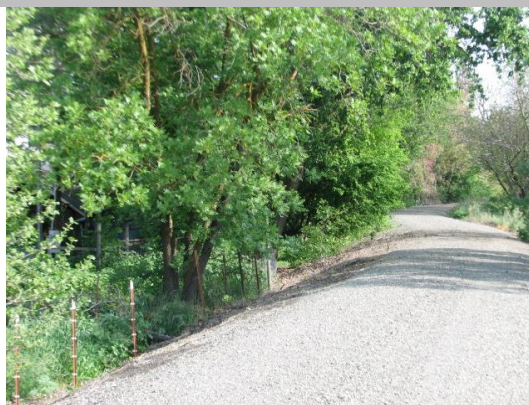
Photo 3 of 3 : SP_2018_ST0001_259_3_20180306_00004.jpg

The landscape needs to be trimmed up. Spring 2014

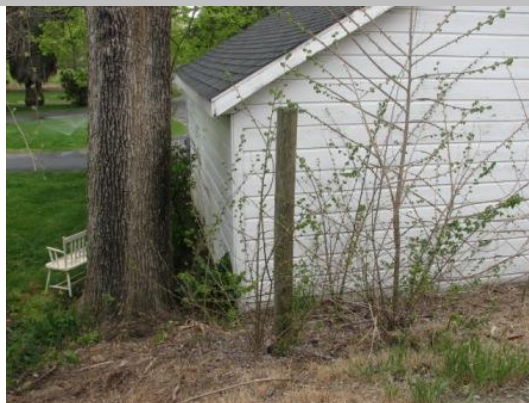
Photo 1 of 1 : SP_2018_ST0001_259_4_20180306_00005.jpg

The building backs up to the landside levee toe of the levee.

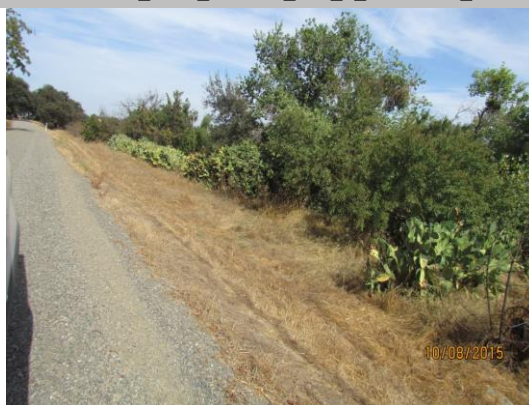
Photo 1 of 1 : SP_2018_ST0001_259_6_20180306_00006.jpg

View of the cactus landscaping on the waterward side of the levee looking downstream. Fall 2015.

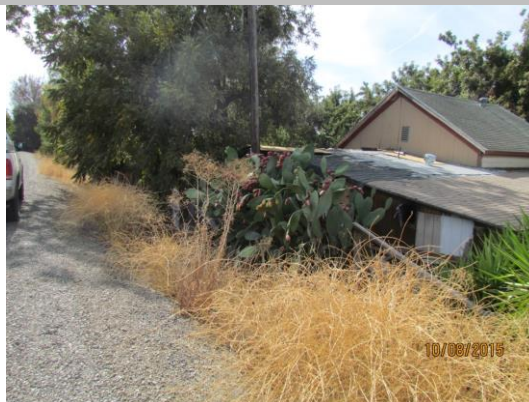
Photo 1 of 1 : SP_2018_ST0001_259_8_20180306_00009.jpg

View of the building on the landward side of the levee looking upstream. Cactus planted at the toe obstructs visibility. Fall 2015.

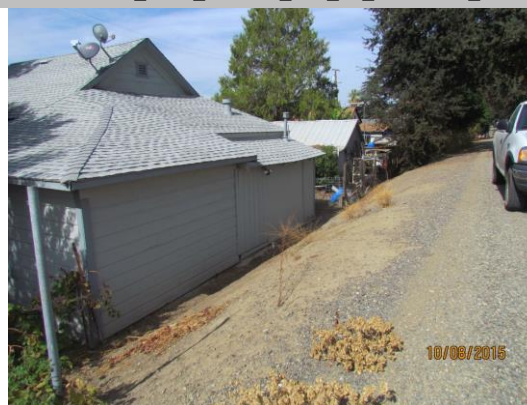
Photo 1 of 1 : SP_2018_ST0001_259_10_20180306_00010.jpg

View of the house on the landward side of the levee looking downstream. Fall 2015.

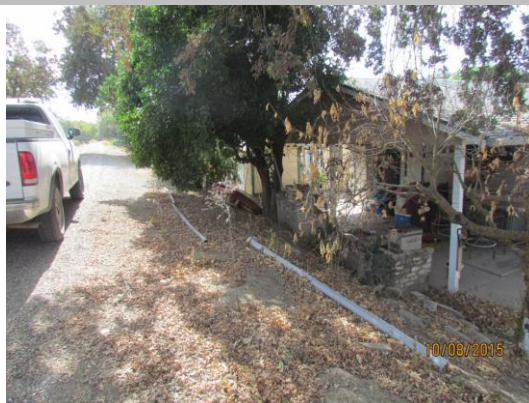
Photo 1 of 1 : SP_2018_ST0001_259_13_20180306_00013.jpg

View of the building on the landward side of the levee looking upstream.
Fall 2015.

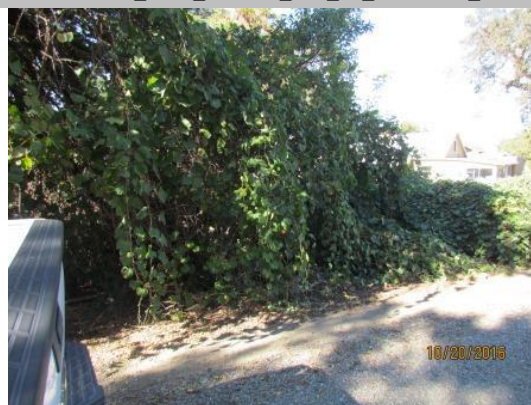
Photo 1 of 2 : SP_2018_ST0001_259_14_20180306_00014.jpg

Another view of the shrubs. Fall 2016.

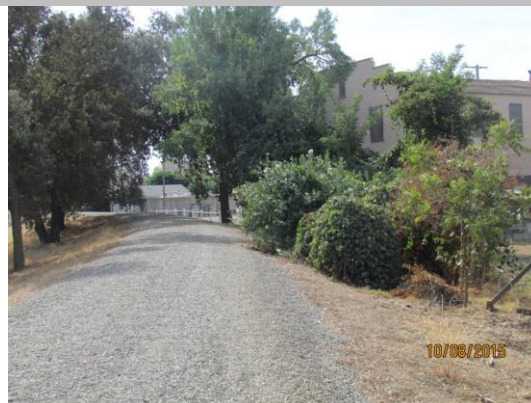
Photo 2 of 2 : SP_2018_ST0001_259_14_20180306_00015.jpg

View of the shrubs on the landward side of the levee looking upstream. Fall 2015.

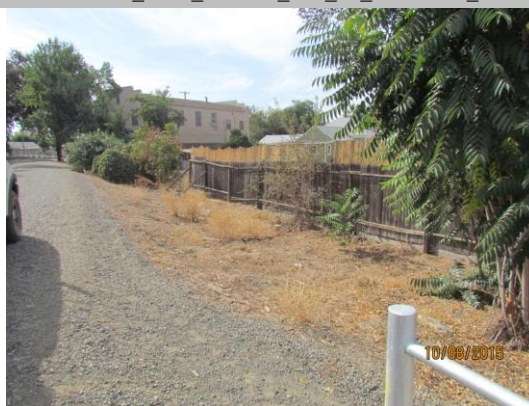
Photo 1 of 1 : SP_2018_ST0001_259_15_20180306_00016.jpg

View of the fence on the landward side of the levee looking upstream.
Fall 2015.

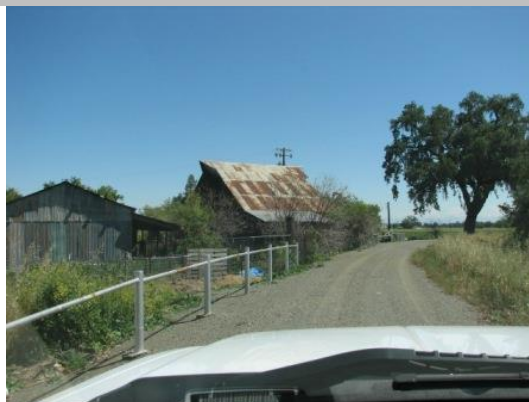
Photo 1 of 2 : SP_2018_ST0001_259_16_20180306_00017.jpg

Horse barn and corral are within the easement of the levee.

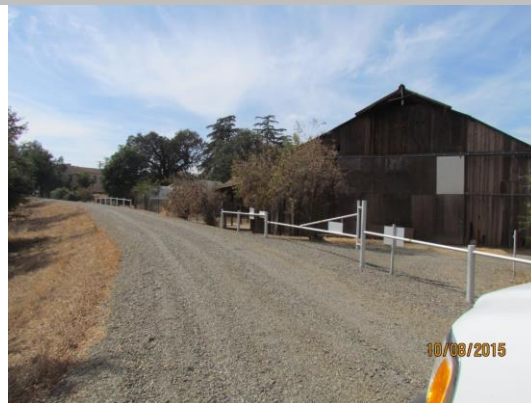
Photo 2 of 2 : SP_2018_ST0001_259_16_20180306_00018.jpg

View of the horse barn on the landward side of the levee looking upstream. Fall 2015.

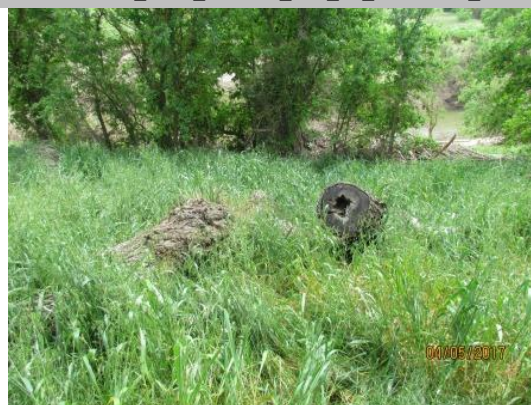
Photo 1 of 1 : SP_2018_ST0001_259_81_20180306_00050.jpg

Dead tree stumps on waterside levee slope. Spring 2017.

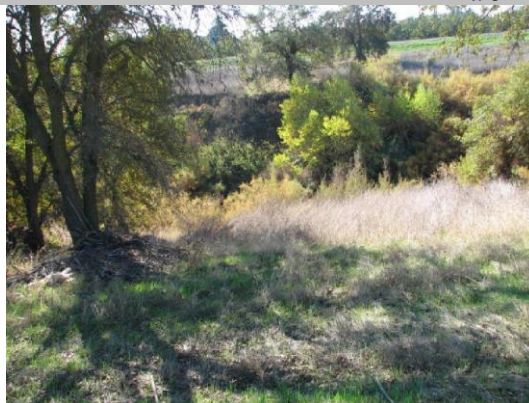
Photo 1 of 3 : UCIP_SP_2018_49099_60164.jpg

Waterside view: no indicators found

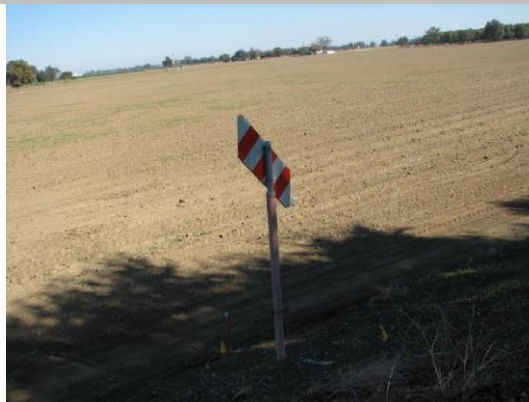
Photo 2 of 3 : UCIP_SP_2018_49099_60163.jpg

Landside view: gasoline indicator

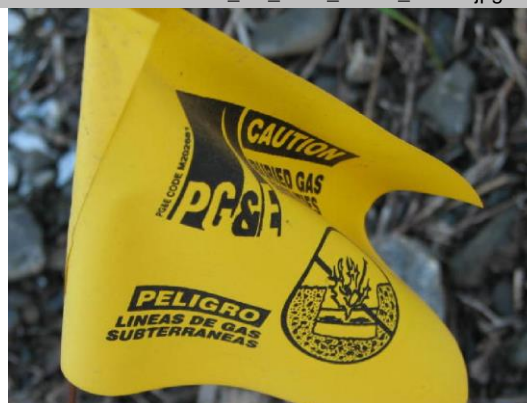
Photo 3 of 3 : UCIP_SP_2018_49099_60165.jpg

Landside view: gasoline indicator/flag

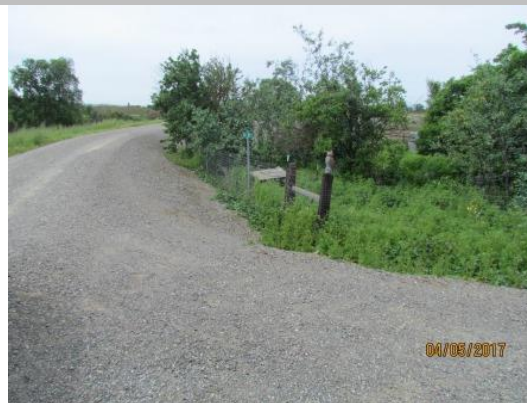
Photo 1 of 1 : SP_2018_ST0001_259_78_20180306_00049.jpg

Chain fence at landside levee toe. Spring 2017.

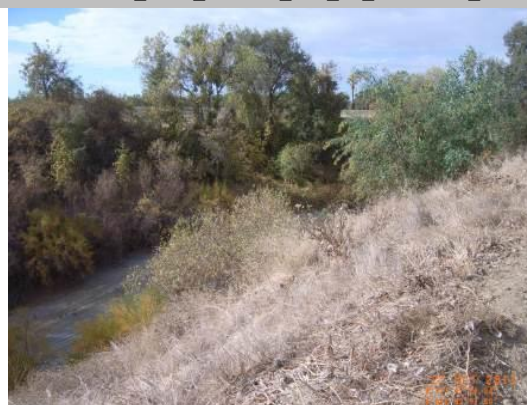
Photo 1 of 1 : SP_2018_ST0001_259_17_20180306_00019.jpg

LM Start	2.57	Rating **	A/W	Issue No.	17
LM End	2.61	Issue Type +	Ma	Location *	WS
Category	Supplemental			GPS Latitude/Longitude	
				Start	End
Item	2015 USACE Erosion Survey, DRAFT			38.732836 °	38.732685 °
				-121.797893 °	-121.797154 °
DWR ID	DWR_ST0001_01_s_2016_17				
Comment Code					
Inspector Comment					
Site identified as CRITICAL in 2002. 2006 - Currently constructing a setback levee. New failures present and extensive. Downstream end of the setback levee did not extend far enough. Upstream end was repaired. 2007 - DWR repaired with a setback levee, but the levee did not go far enough downstream. 2012 - New cracks observed. 2013 - Fresh erosion on upper bank. 2015: No observed changes. [2015 Site ID: CHC_2-4_L]

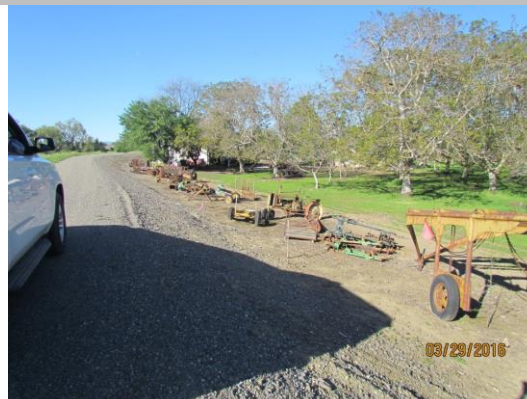
Photo 1 of 1 : SP_2018_ST0001_259_71_20180306_00046.jpg

View of the equipment on the landward side of the levee looking upstream. Spring 2016.

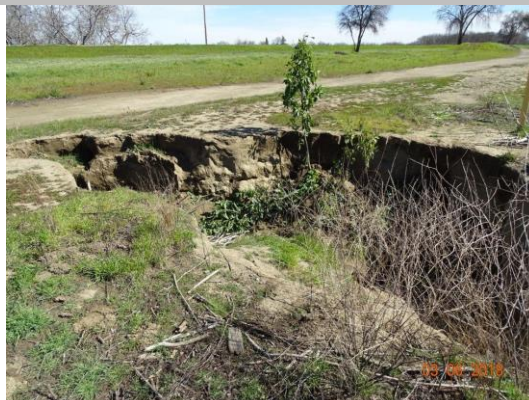
Photo 2 of 5 : SP_2018_ST0001_259_62_20180308_00073.jpg

View of erosion looking towards the landside levee slope, facing northeast. Spring 2018.

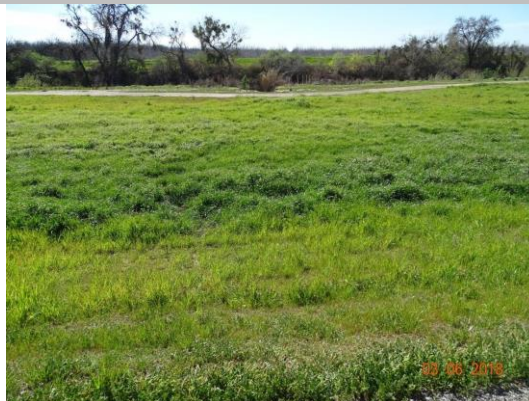
Photo 5 of 5 : SP_2018_ST0001_259_62_20180308_00075.jpg

View of erosion from levee crown, facing Cache Creek. Fall 2018.

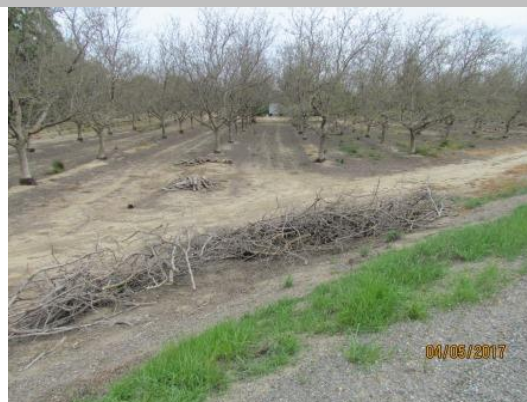
Photo 1 of 1 : SP_2018_ST0001_259_75_20180306_00047.jpg

Prunings at landside levee toe. Spring 2017.

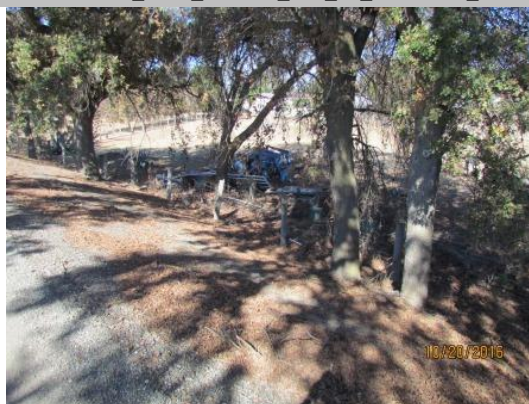
Photo 1 of 1 : SP_2018_ST0001_259_52_20180306_00040.jpg

LM Start	4.34	Rating **	M	Issue No.	52
LM End	4.42	Issue Type +	En	Location *	LS
Category	Earthen Levee			GPS Latitude/Longitude	
				Start	End
Item	Encroachments			38.726754 °	38.726242 °
				-121.773424 °	-121.772221 °
DWR ID	DWR_ST0001_01_f_2016_52				
Comment Code					
FE : Fence					
Inspector Comment					
Fence on LS slope.

Fence on landside slope. Fall 2016.

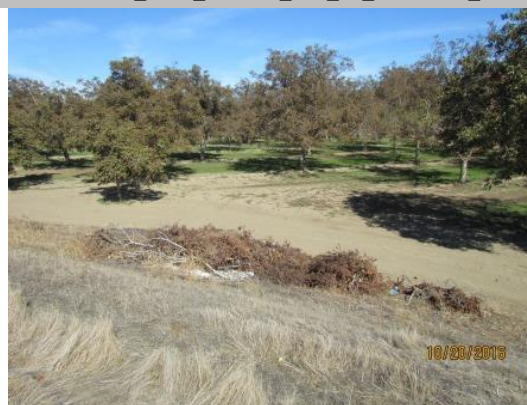
Photo 1 of 1 : SP_2018_ST0001_259_51_20180306_00039.jpg

View of prunings on LS slope. Fall 2016.

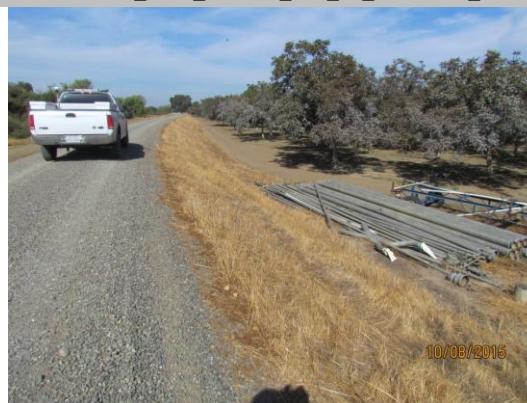
Photo 1 of 1 : SP_2018_ST0001_259_24_20180306_00022.jpg

View of the aluminum irrigation pipe along the levee toe of the landward side looking upstream. Fall 2015.

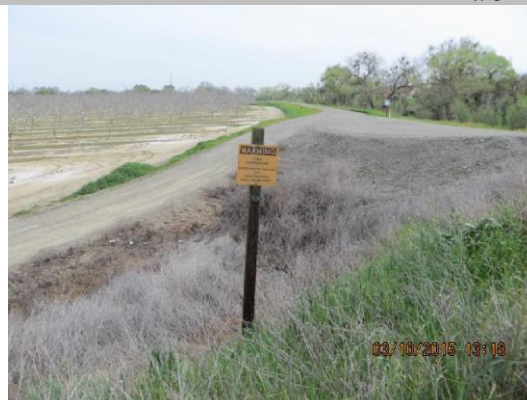
Photo 1 of 2 : UCIP_SP_2018_49111_73501.jpg

Sign on LS toe.

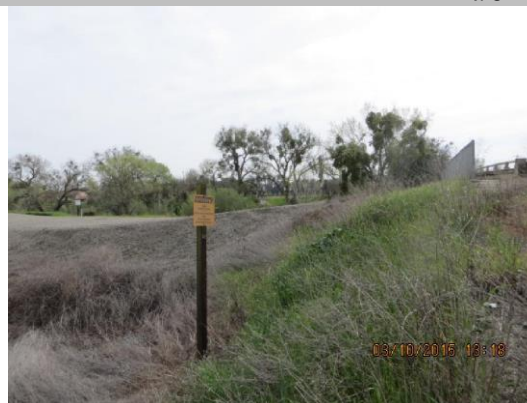
Photo 2 of 2 : UCIP_SP_2018_49111_73500.jpg

Sign on LS toe.

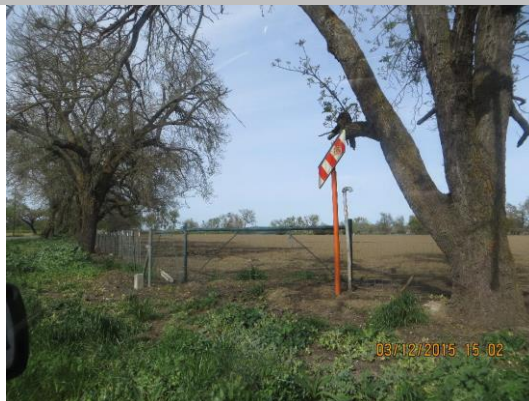
Photo 2 of 2 : UCIP_SP_2018_49112_73503.jpg

Gasline marker at Best Ranch Road, 1500-feet south of levee crossing.

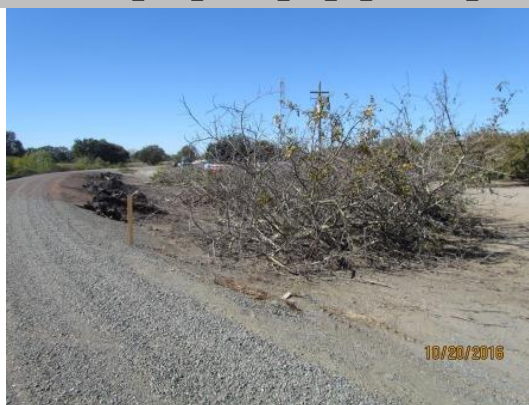
Photo 2 of 2 : SP_2018_ST0001_259_45_20180306_00035.jpg

View of prunings on landside slope. Fall 2016.

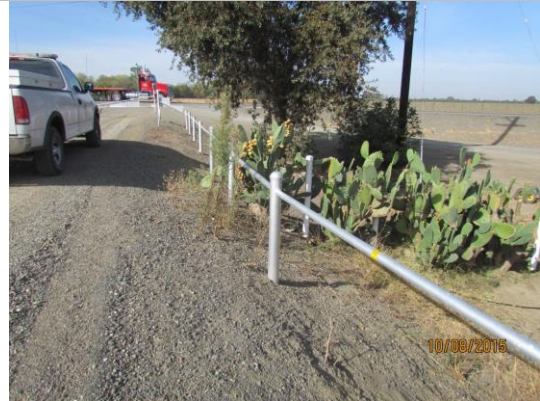
Photo 1 of 1 : SP_2018_ST0001_259_57_20180306_00041.jpg

View of the cactus on the landward side of the levee looking upstream.
Fall 2015.

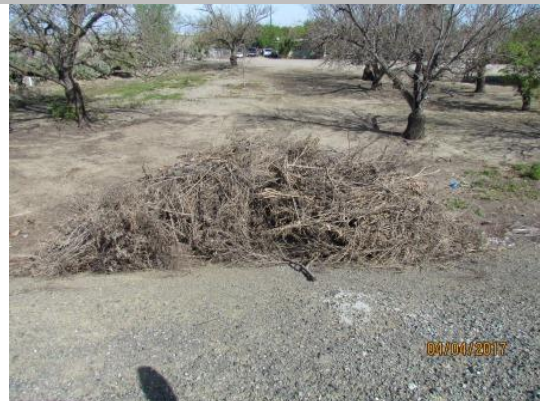
Photo 1 of 1 : SP_2018_ST0001_259_35_20180306_00029.jpg

Prunings at landside levee toe. Spring 2017.

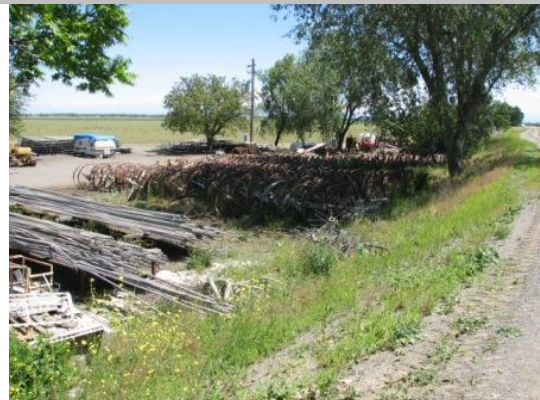
Photo 1 of 2 : SP_2018_ST0001_259_40_20180306_00032.jpg

Irrigation pipe and equipment are within the easement of the levee.

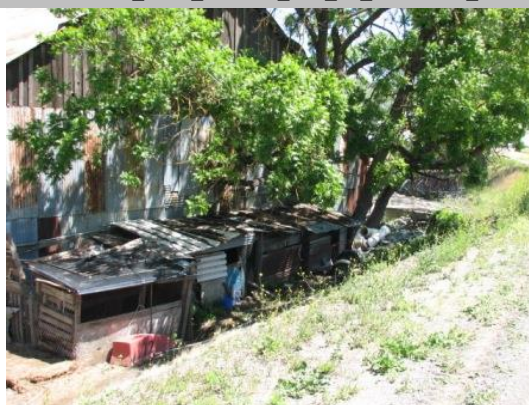
Photo 1 of 1 : SP_2018_ST0001_259_39_20180306_00031.jpg

The barn and livestock pens are within the easement of the levee.

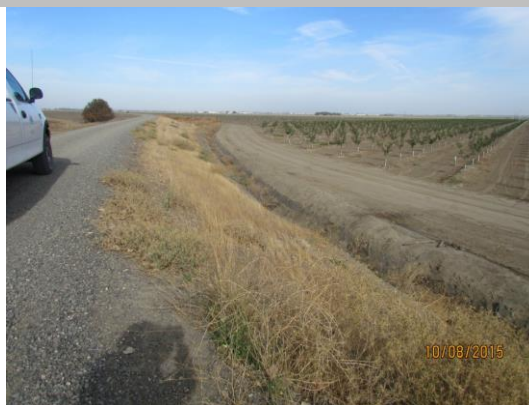
Photo 2 of 2 : SP_2018_ST0001_259_26_20180306_00024.jpg

View of the ditch on the landward side of the levee looking upstream. Fall 2015.

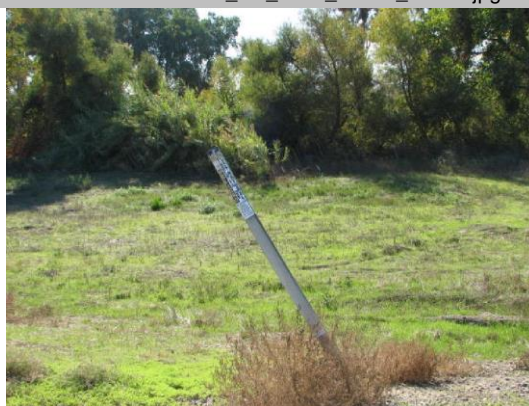
Photo 1 of 2 : UCIP_SP_2018_50811_60197.jpg

Waterside view: gasline indicator

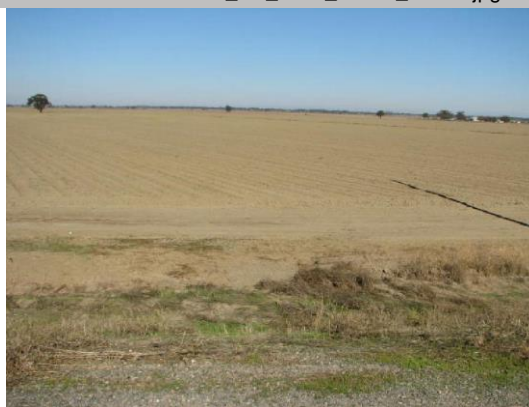
Photo 2 of 2 : UCIP_SP_2018_50811_60196.jpg

Landside view: no indicator found.

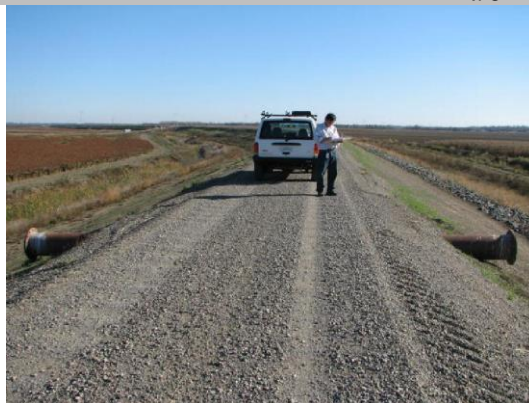
Photo 1 of 3 : UCIP_SP_2018_52531_60219.jpg

Crown view: overview

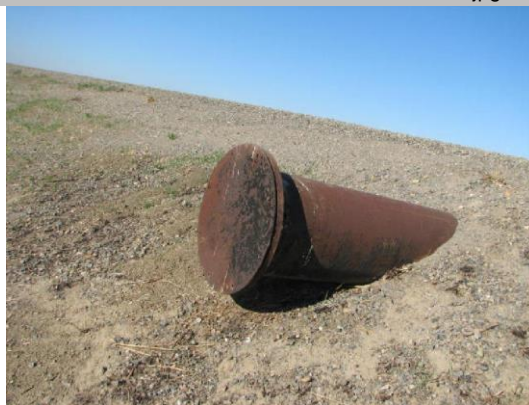
Photo 2 of 3 : UCIP_SP_2018_52531_60223.jpg

Waterside view: closer look at capped pipe.

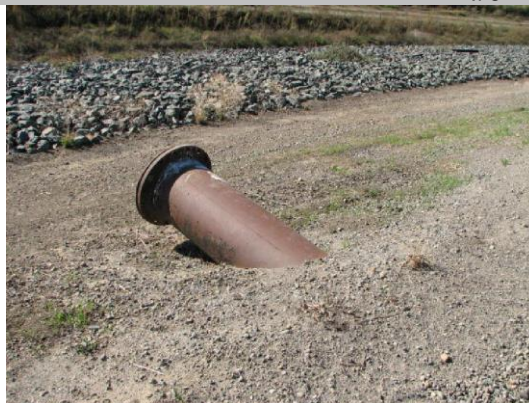
Photo 3 of 3 : UCIP_SP_2018_52531_60222.jpg

Waterside view: steel pipe on the slope of the levee

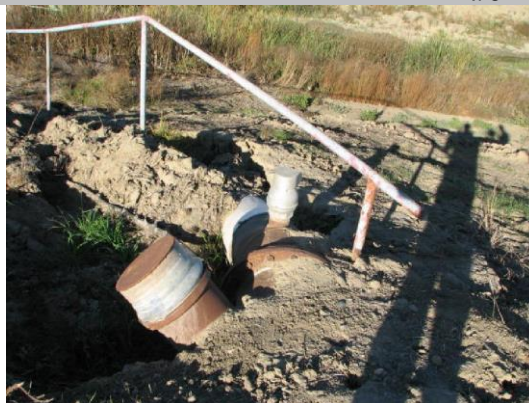
Photo 2 of 3 : UCIP_SP_2018_52532_60147.jpg

Landside view: pipe daylight on LS levee slope

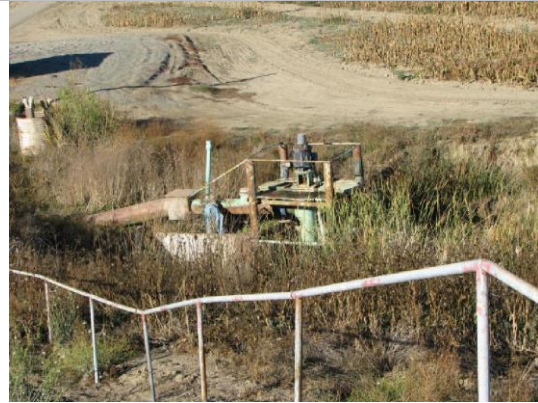
Photo 3 of 3 : UCIP_SP_2018_52532_60149.jpg

Landside view: pumping plant

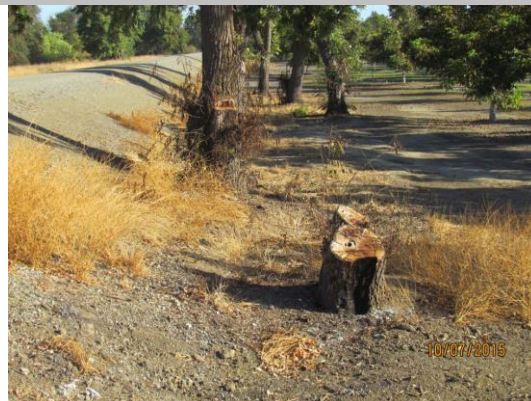
Photo 1 of 1 : SP_2018_ST0001_260_10_20180306_00011.jpg

View of the tree stump at the landward side of the levee looking downstream. Fall 2015.

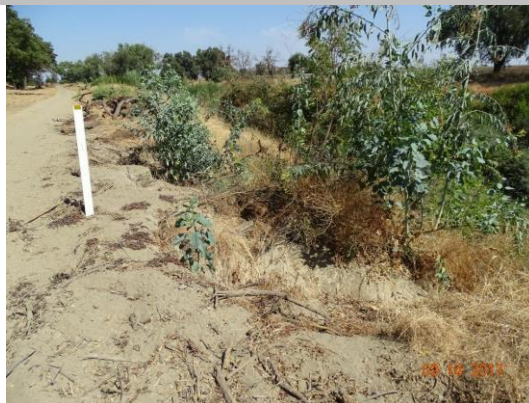
Photo 1 of 1 : SP_2018_ST0001_260_16_20180306_00017.jpg

View of storm damage site on waterside berm. Does not appear to be within the levee prism at this time. Fall 2017.

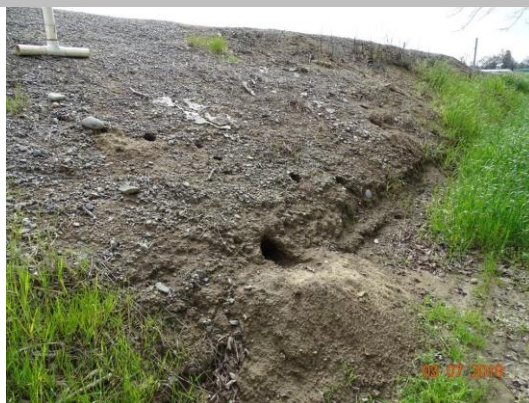
Photo 1 of 1 : SP_2018_ST0001_260_38_20180308_00025.jpg

View of rodent holes on the landside slope. Spring 2018.

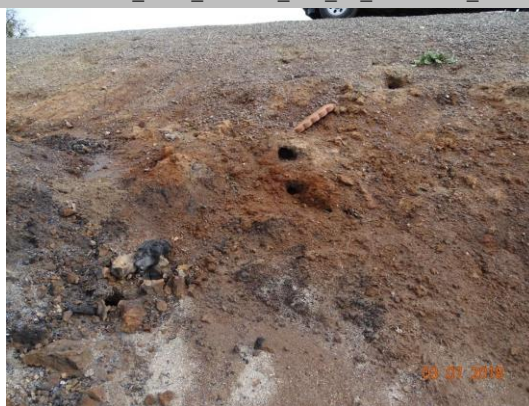
Photo 1 of 1 : SP_2018_ST0001_260_35_20180308_00024.jpg

View of rodent holes on the landside slope. Spring 2018.

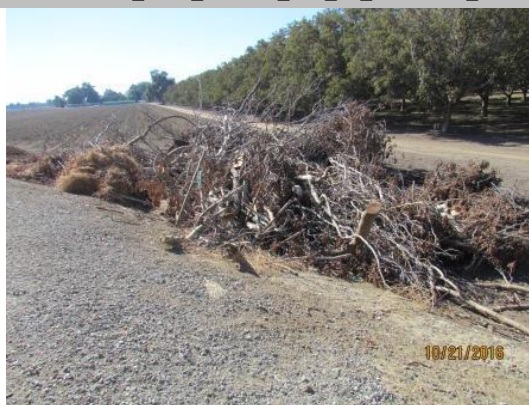
Photo 1 of 1 : SP_2018_ST0001_260_20_20180306_00019.jpg

View of prunings on LS slope of the levee. Fall 2016.

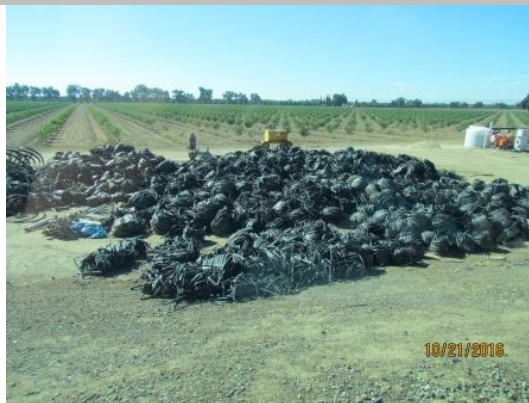
Photo 1 of 2 : SP_2018_ST0001_260_3_20180306_00003.jpg

Additional view of debris at the same site on landward side of the levee. Fall 2016.

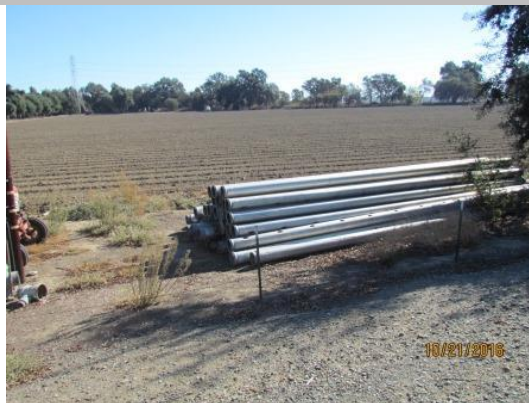
Photo 1 of 1 : SP_2018_ST0001_260_12_20180306_00012.jpg

Pipes are stored at levee toe on landside. Fall 2016.

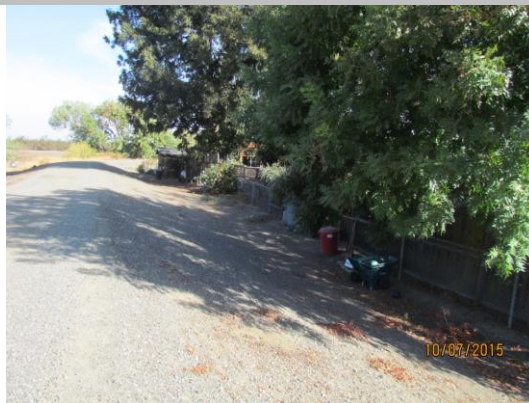
Photo 1 of 1 : SP_2018_ST0001_260_7_20180306_00008.jpg

View of the landscaping and fence on the landward side of the levee looking downstream. Fall 2015.

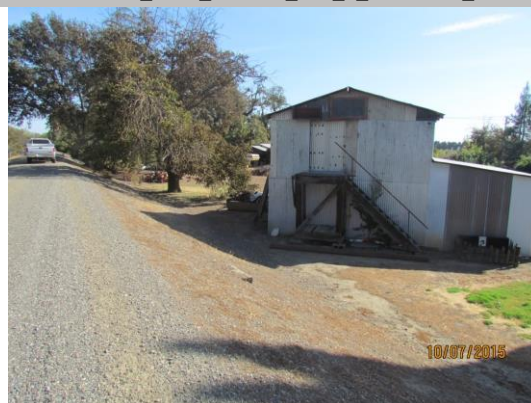
Photo 1 of 1 : SP_2018_ST0001_260_8_20180306_00009.jpg

View of the building on the landward side of the levee looking downstream. Fall 2015.

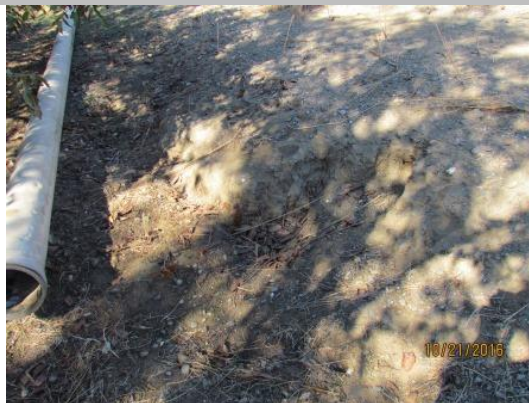
Photo 1 of 1 : SP_2018_ST0001_260_4_20180306_00005.jpg

Erosion on LS levee slope toward the toe. Fall 2016.

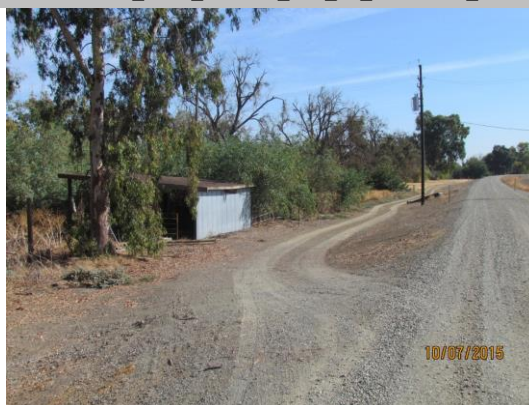
Photo 1 of 1 : SP_2018_ST0001_260_27_20180306_00021.jpg

View of the horse corral and building on the waterward side of the levee looking downstream. Fall 2015.

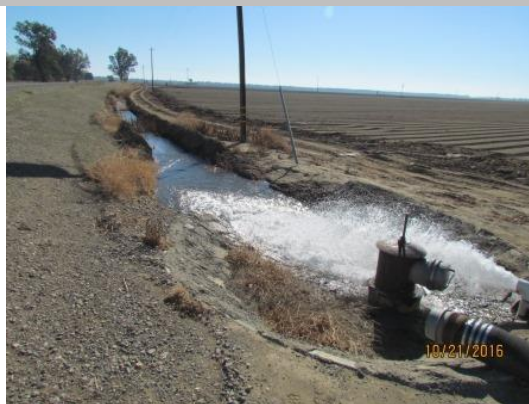
Photo 1 of 2 : SP_2018_ST0001_260_14_20180306_00014.jpg

View of ditch on landside near the levee toe looking downstream of Cache Creek. Fall 2016.

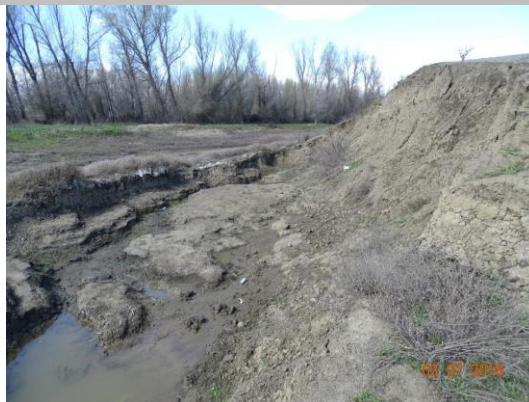
Photo 1 of 4 : SP_2018_ST0001_261_3_20180308_00006.jpg

LM Start	2.26	Rating **	A/W	Issue No.	3
LM End	2.26	Issue Type +	Ma	Location *	WS
Category	Earthen Levee			GPS Latitude/Longitude	
				Start	End
Item	Erosion / Bank Caving			38.695416 °	38.695416 °
				-121.715943 °	-121.715943 °
DWR ID	DWR_ST0001_04_s_2017_3				
Comment Code					
E2 : Schedule repair of erosion site prior to the next inspection.					
Inspector Comment					
Scour on waterside levee slope at end of Unit 04 levee. There is no visible active erosion at this time, however future high water events will likely cause further erosion into the levee prism.

View of scour on waterside levee slope at the end of Unit 4. Spring 2018.

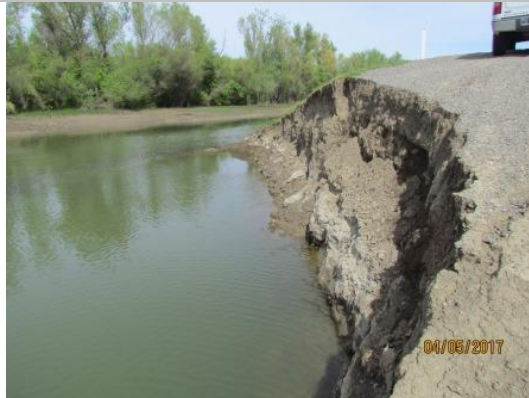
Photo 4 of 4 : SP_2018_ST0001_261_3_20180306_00005.jpg

Scour on waterside levee slope at end of Unit 04 levee. Spring 2017.
